Attachment 1 – Pictures of Inspection Findings

AD 2006-15-15

Figure 1 of MD80 Alert
Service Bulletin

MD80-29A070 Rev 2

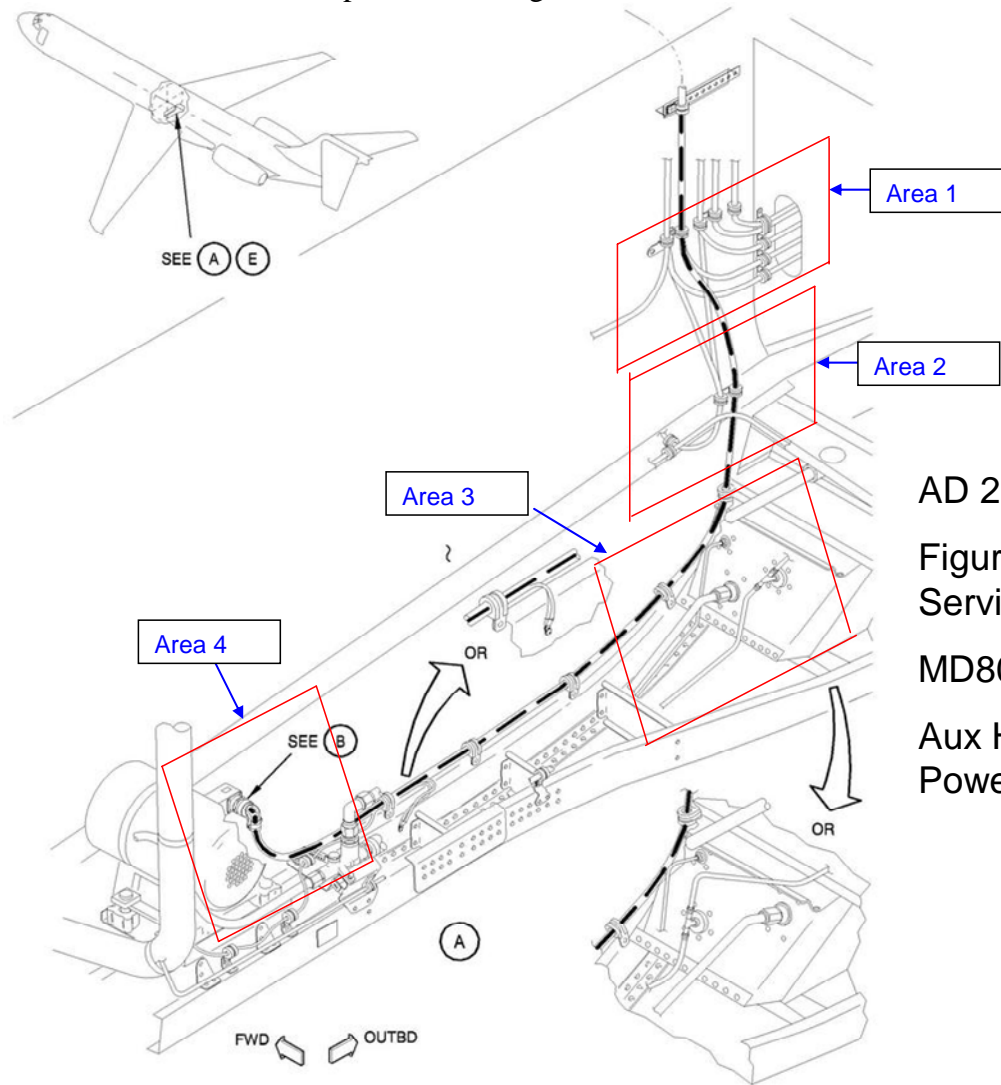
Areas with findings
are noted

Aux Hydraulic Pump
Power Cable Route

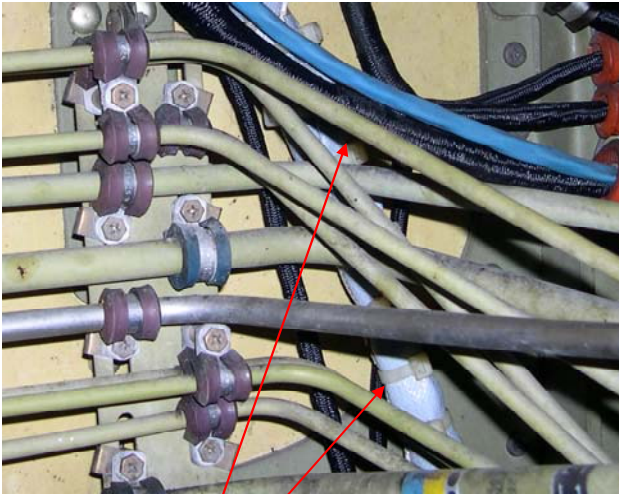
Incorrect - Use of Nylon Tie Wraps

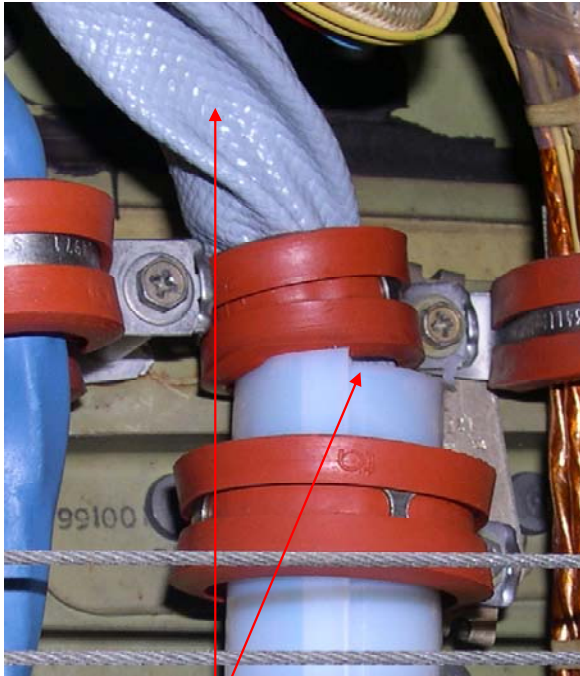
Incorrect – Snap tube installed too long. No tie tape used

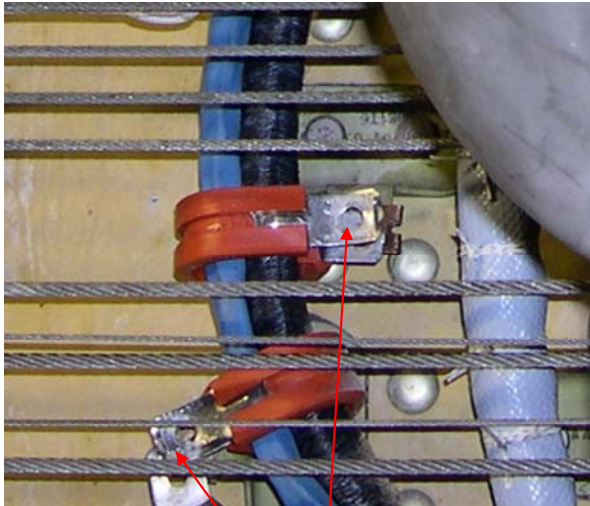
Incorrect – Clamp not secured

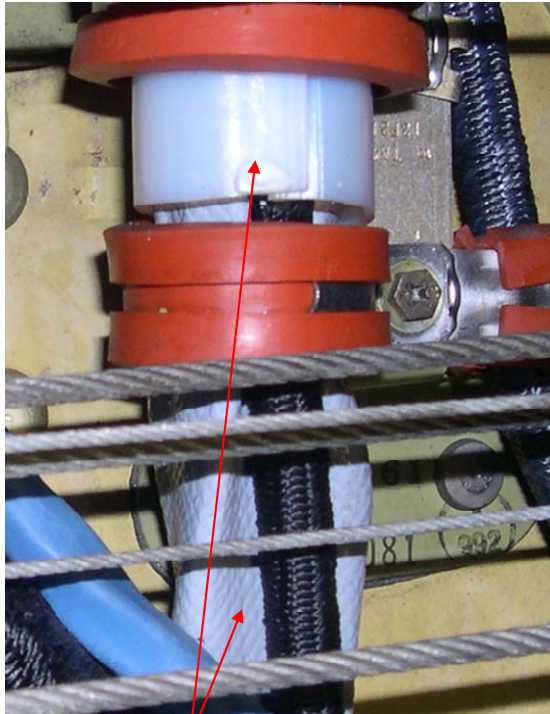
Incorrect – Snap tube too Long and no tie tape

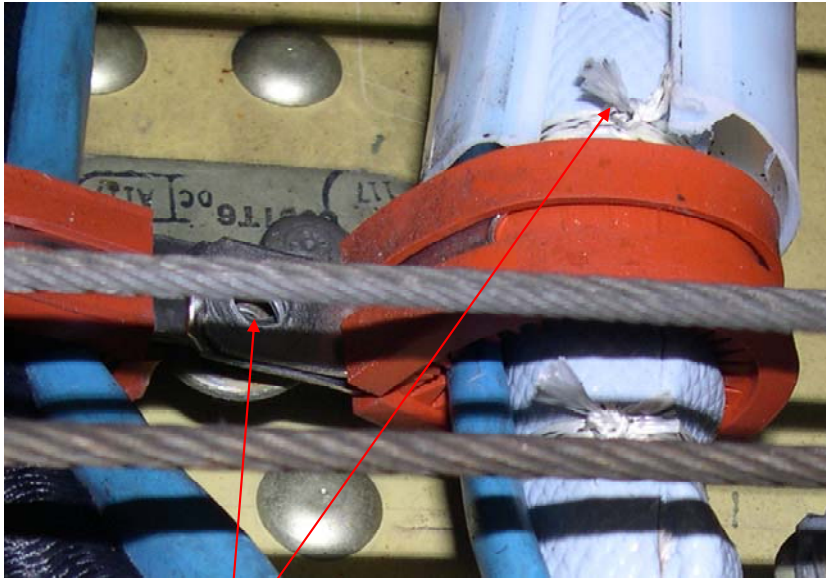
Incorrect – Clamp not installed and snap tube open and not installed in clamp

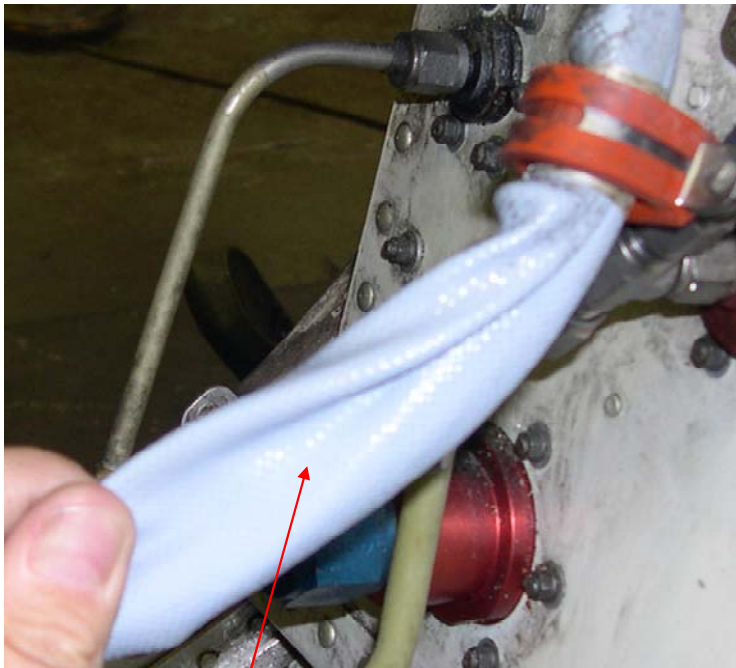
Incorrect – No tie tape installed

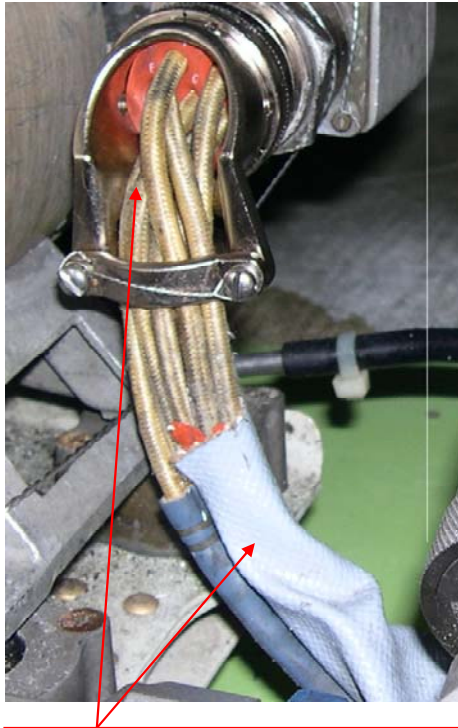
**Incorrect – No wrap on
Back shell of connector
and no tie tape**
